Ciarametaro Expert Report

Expert Witness Report

Thomas P. Ciarametaro
Five Fathoms Consulting LLC
June 14th, 2024

No. 1:23-CV-00853-DAE
United States District Court
Western District of Texas - Austin Division

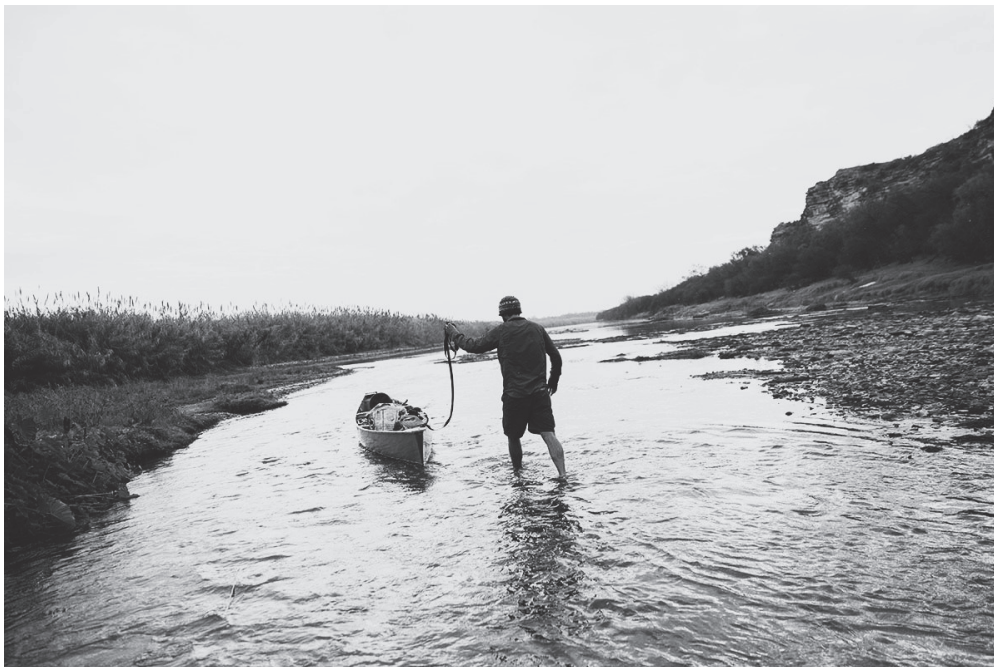
Figure 4. Expedition member dragging a canoe down the Rio Grande River in in an ankle-deep water. *Id.*

Cpt. Ciarametaro found similar conditions from his review of a video recording between Mile Markers 275.5 and 610 and during a site visit on June 7, 2024, to the area near Eagle Pass, TX.

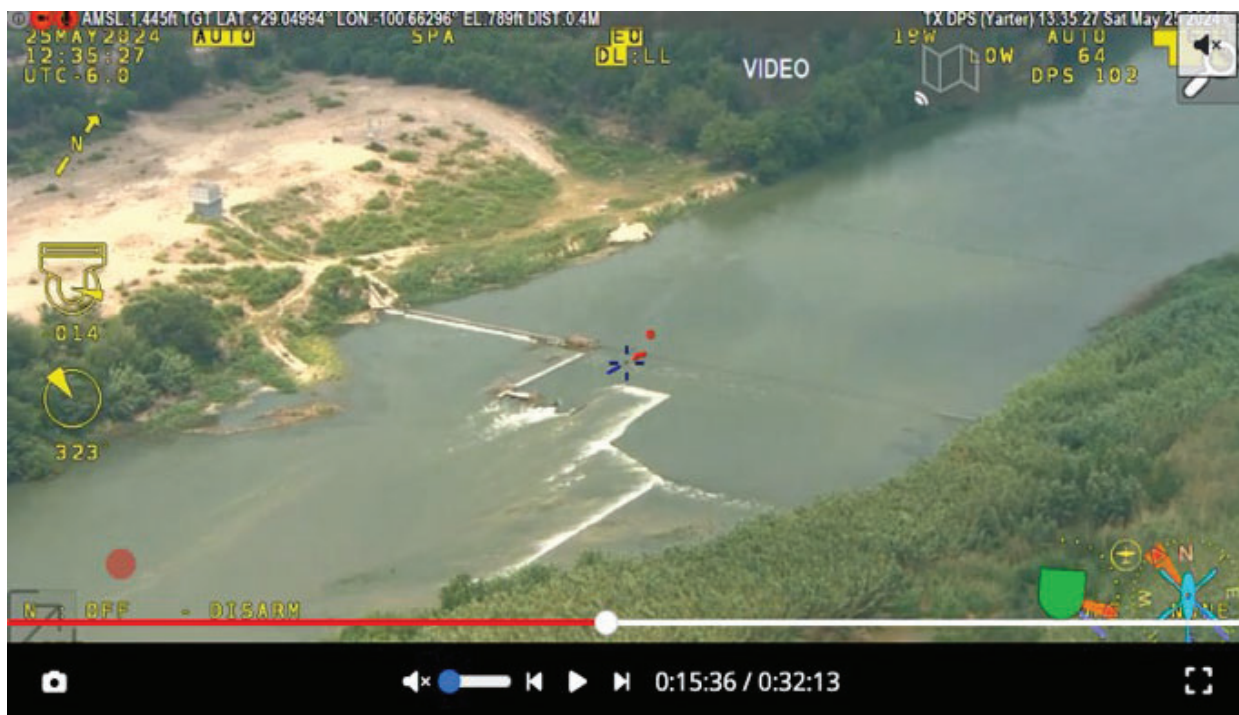
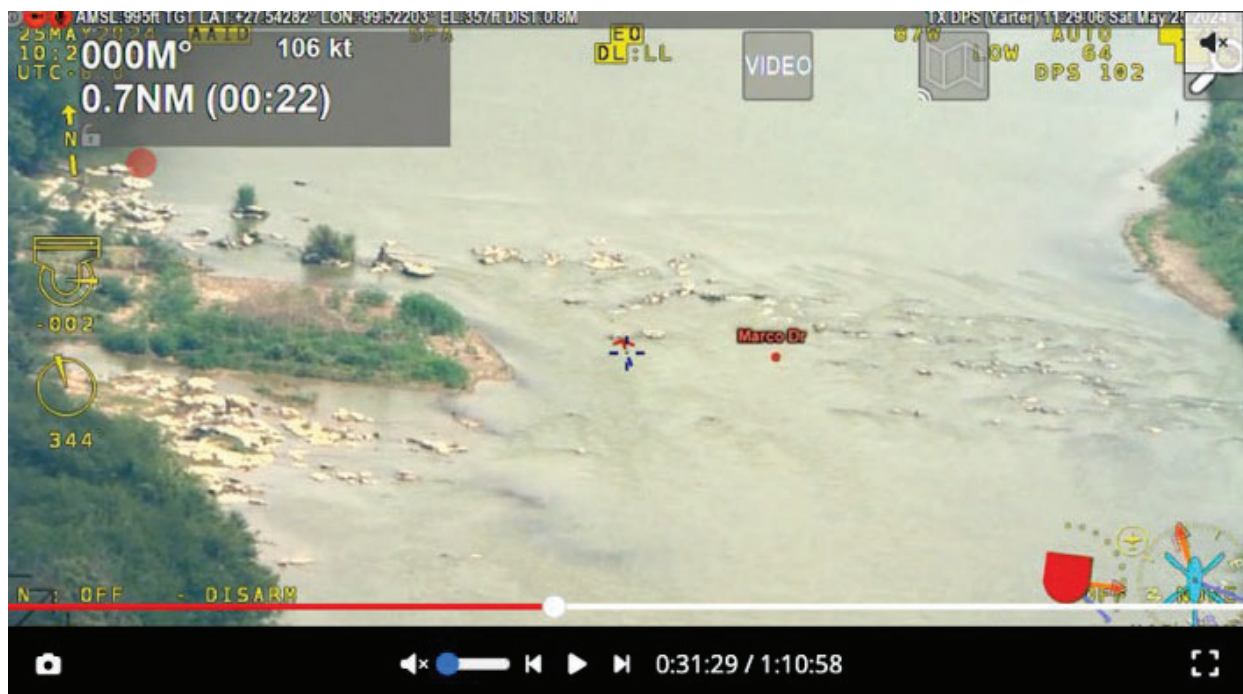
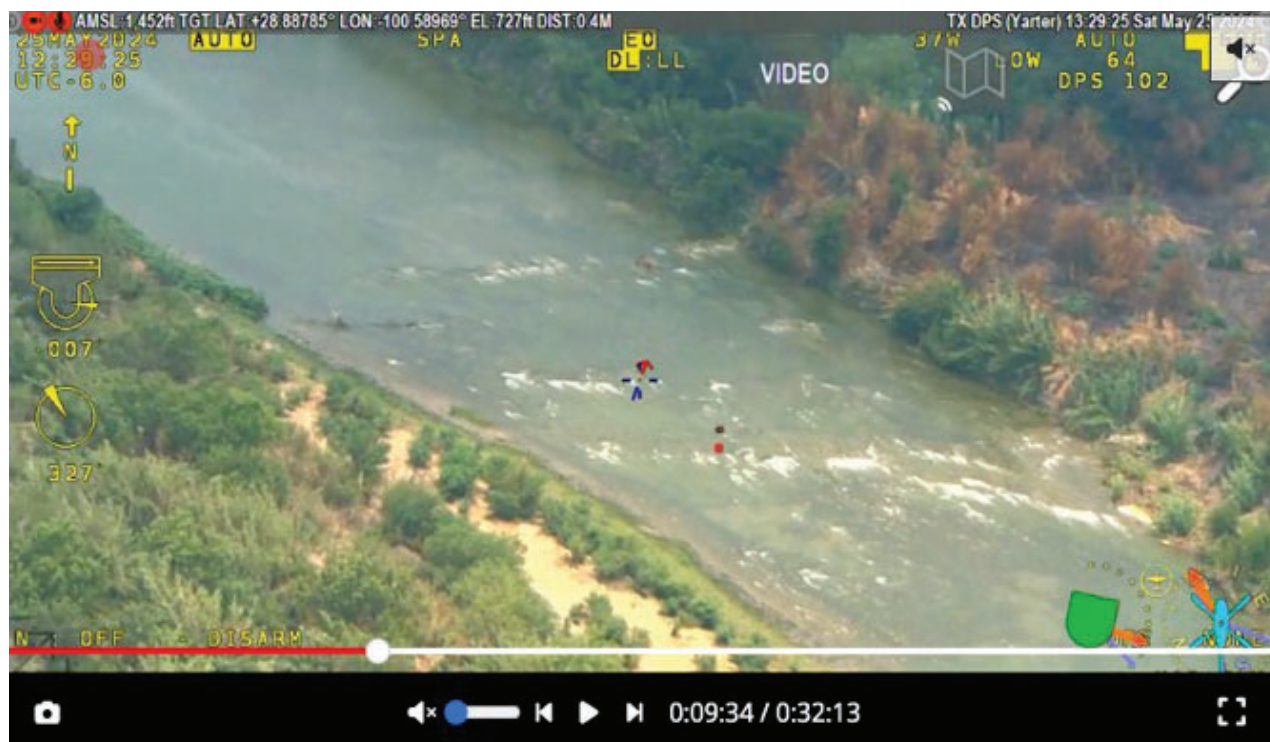
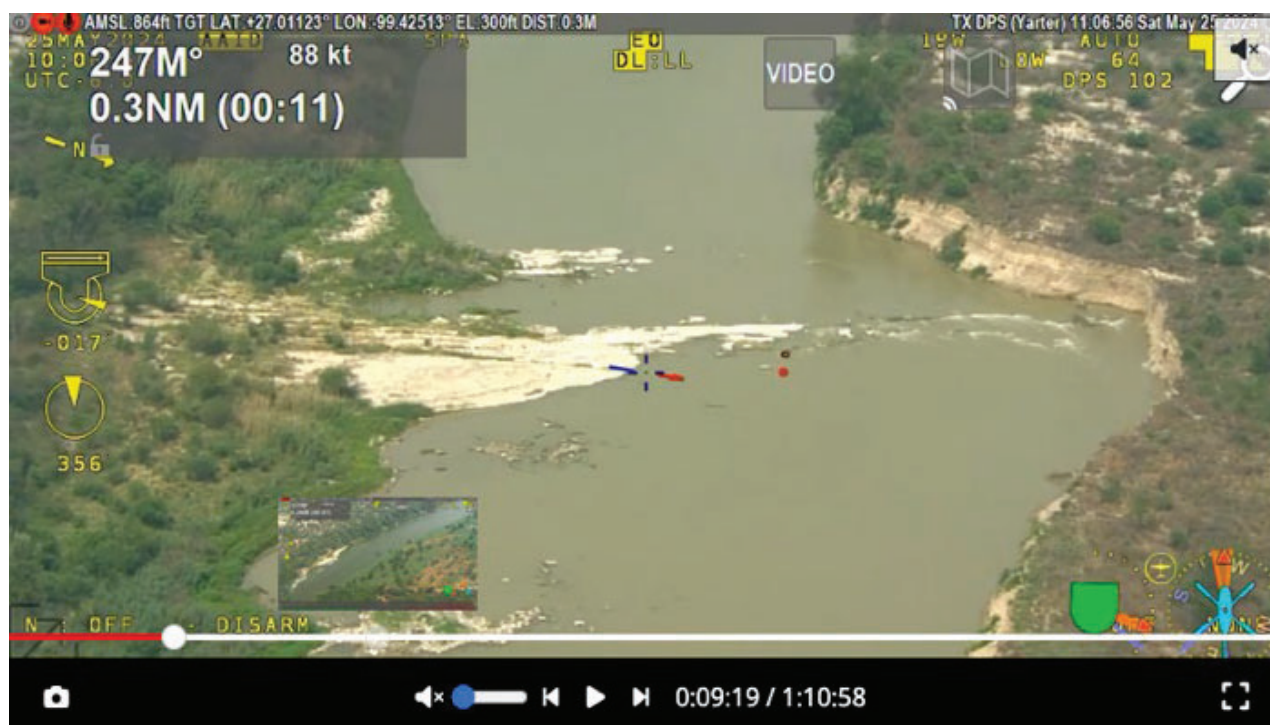
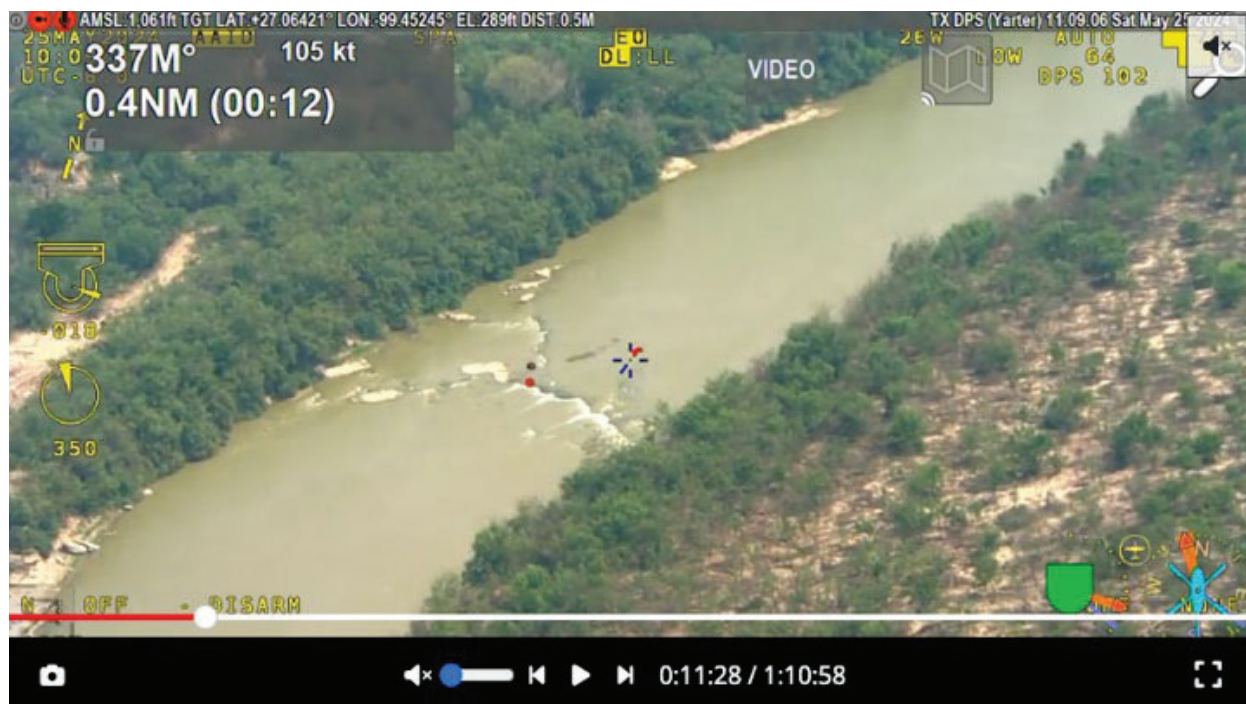
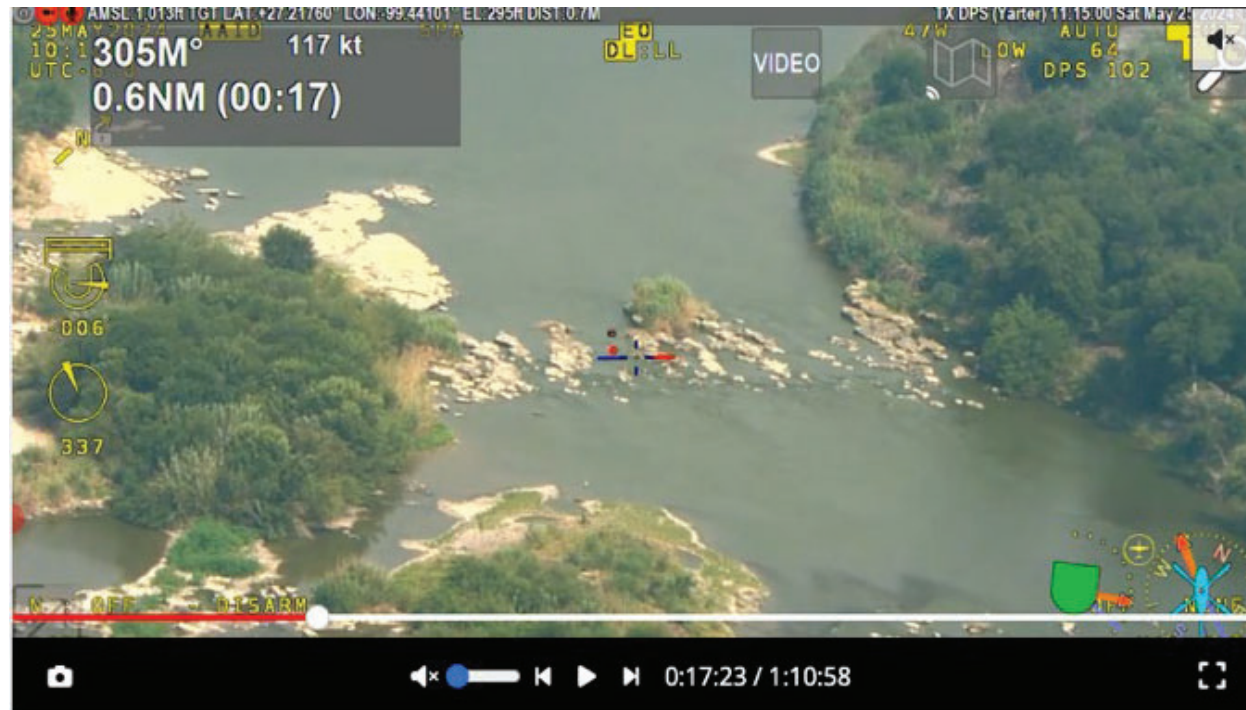
Figure 7. Image showing impassable water conditions.

Figure 8. Image showing impassable water conditions.

Figure 9. Image showing impassable water conditions.

Figure 10. Image showing impassable water conditions.

Figure 11. Image showing impassable water conditions.

Figure 12. Image showing impassable water conditions.

Cpt. Ciarametaro observed *numerous* locations that were impassible to Class A and Class 1 vessels, small vessels, and any vessel or barge carrying commercial cargo, including but not limited to the following images and their corresponding time stamps:

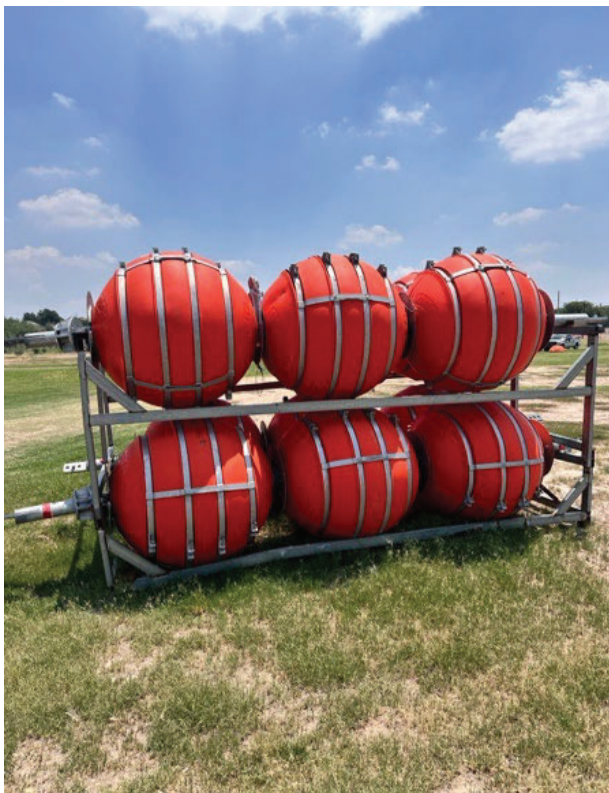
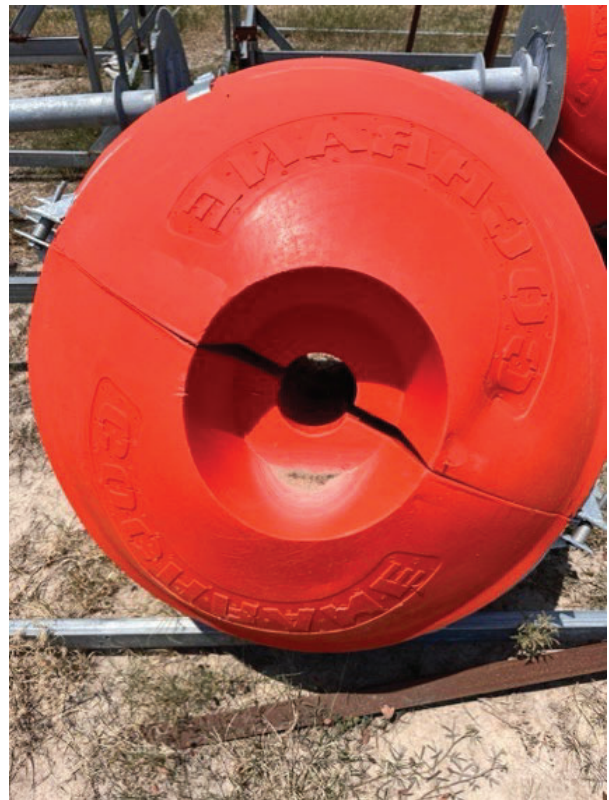
Figures 13 & 14. Pictures of the buoys.

The buoys in the Rio Grande River are a strategic barrier consisting of a series of connected, floating buoys placed along the river's eastern course along the Texas border that is intended to deter border crossings into the state and warning mariners of the concrete moorings to which they are attached that may be underneath the water, while still allowing unimpeded

navigation by viable watercraft. They are strategically positioned to address security concerns without significantly disrupting the flow of water or obstructing legitimate and ordinary maritime and small vessel activities along the border. During the Cpt. Ciarametaro's site-visit it was observed that water levels at the area where the buoys were installed were so low that some of them were aground. This further supports the conclusion that these buoys do not impede vessels traversing the river.

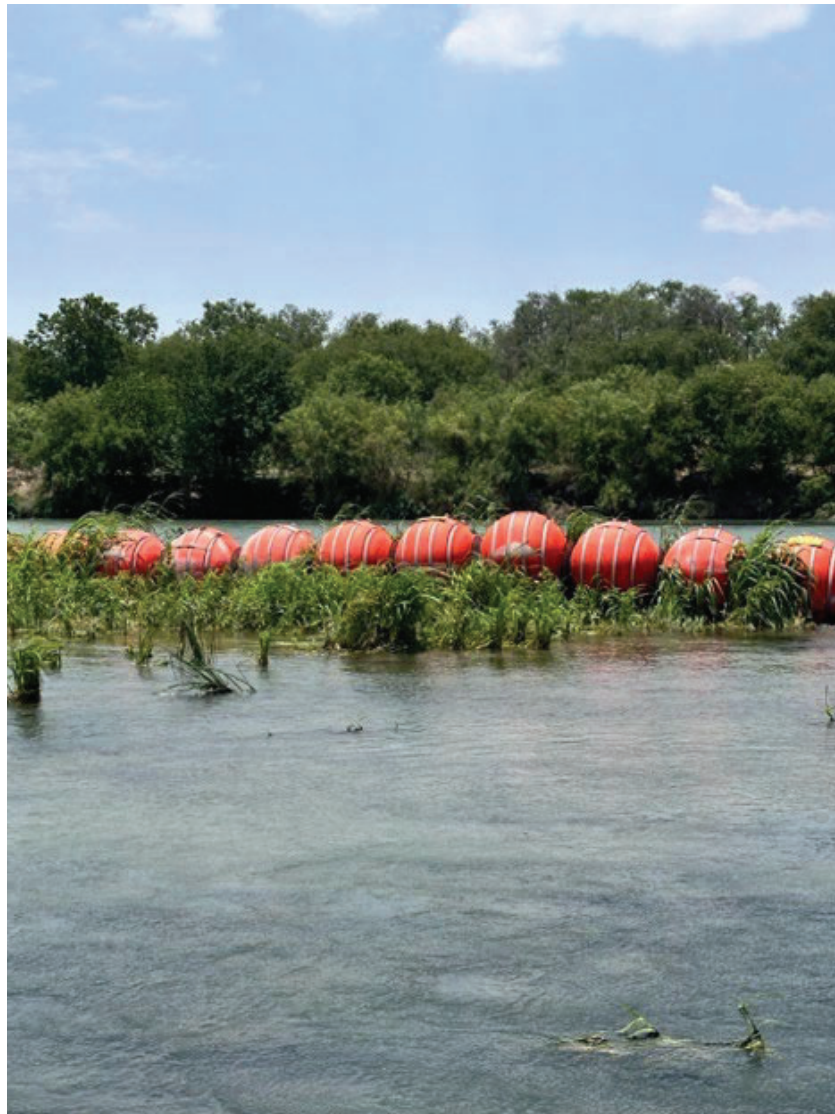
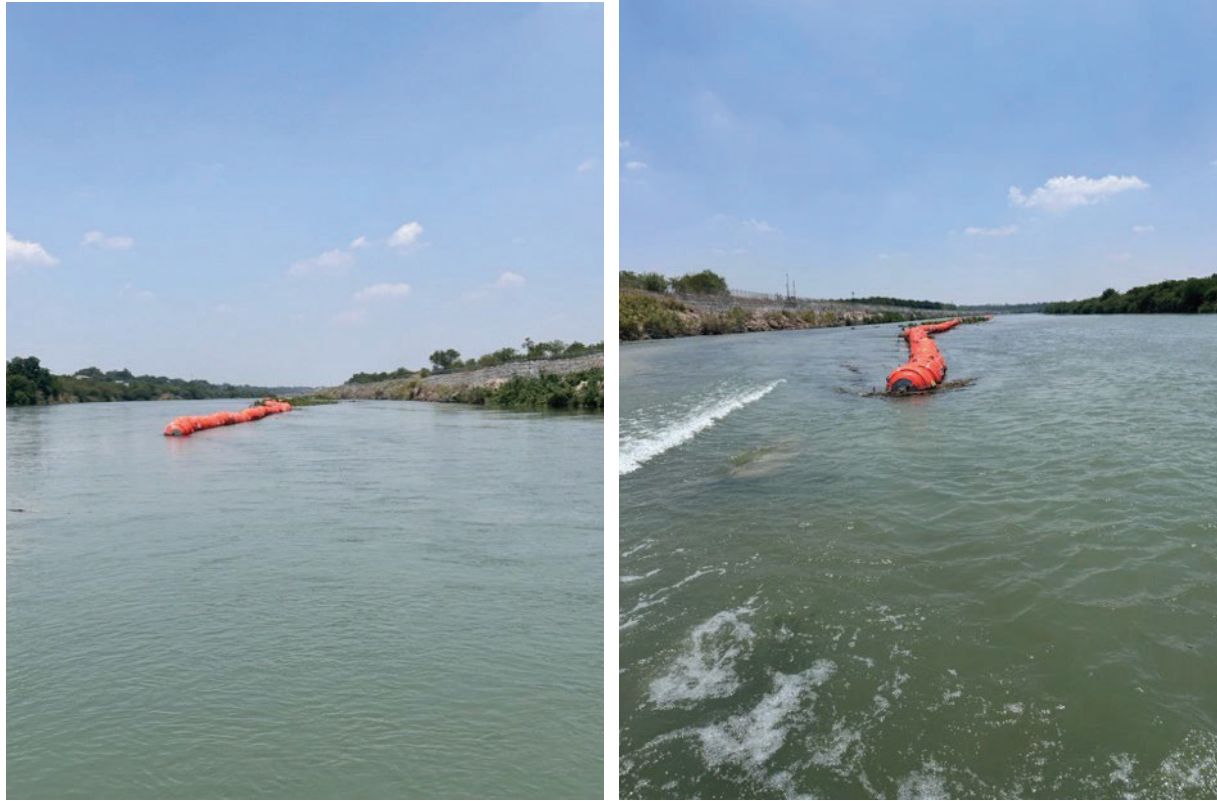
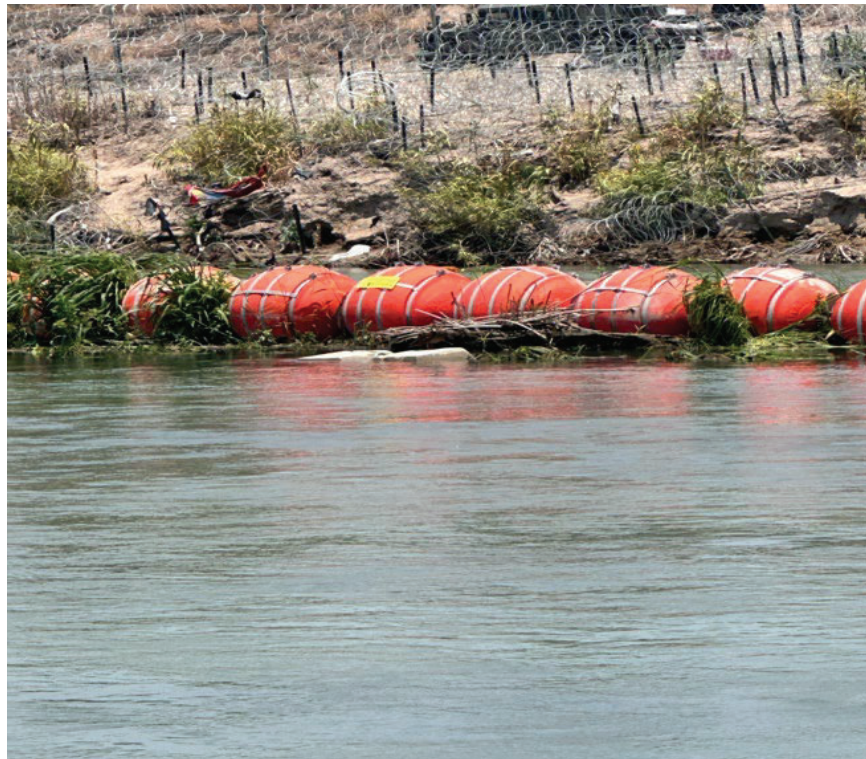
Figure 15. Pictures of the buoys taken by Cpt. Ciarametaro during site visit.

Figures 16 & 17. Pictures of the buoys taken by Cpt. Ciarametaro during site visit

Figures 18. Pictures of the buoys taken by Cpt. Ciarametaro during site visit

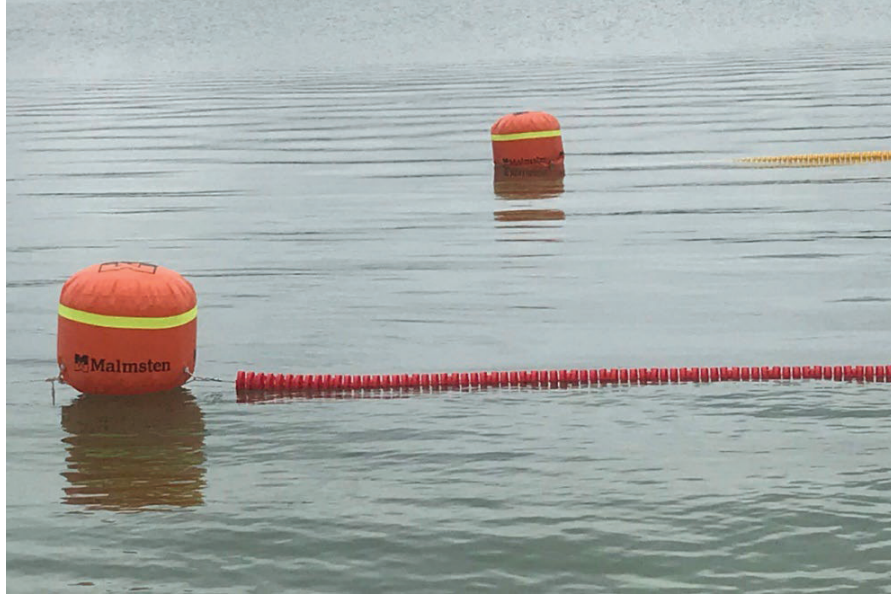
Figures 19. Example of a swim buoy system. *Characteristics of a swimming buoy*, AceBoater.com (accessed June 14, 2024), <https://tinyurl.com/4kv6ebhv>.

Figures 20. Another example of a swim buoy system. *Swim Course Marker Buoy*, Malmsten (accessed June 14, 2024), <https://tinyurl.com/ye244dnk>.

The barrier in Eagle Pass, Texas, is comprised of buoys rather than floats due to several defining characteristics and functions. Buoys are anchored devices used primarily for marking positions on the water and serving specific purposes such as navigation, mooring, or delineating boundaries. Unlike floats, which are typically movable objects without fixed positions, buoys are designed to remain stable and fixed in a specific location, often tethered to the seabed. This stability is crucial for the barrier's function in Eagle Pass. Moreover, the barrier is helpfully visible and thus serves the specific purpose of deterring illegal crossings and alerting mariners to their concrete moorings. Therefore, based on their anchored design, specific purpose, and practical application in marking boundaries, it is clear that the devices used in Eagle Pass are buoys and not floats.

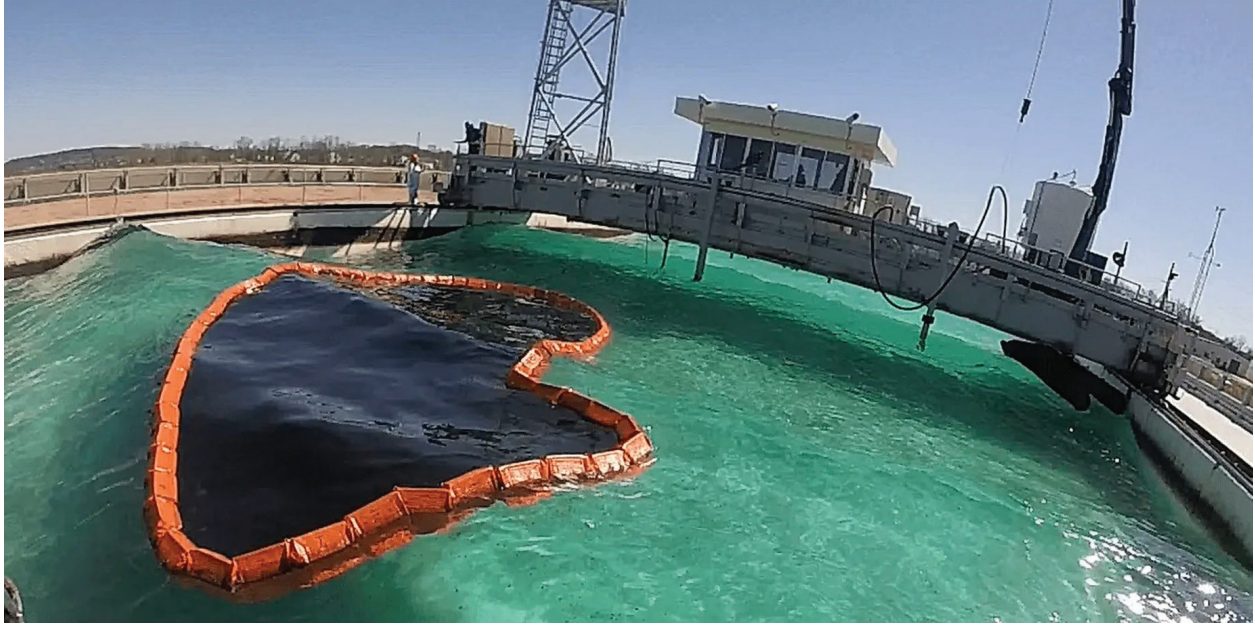
Figures 21. An example of a containment boom. *All About Oil Spill Containment Booms*, UltraTech Int'l (accessed June 14, 2024), <https://tinyurl.com/yc2r5m2n>.

Booms are often used in accidents, such as oil spills, as a means of containment.

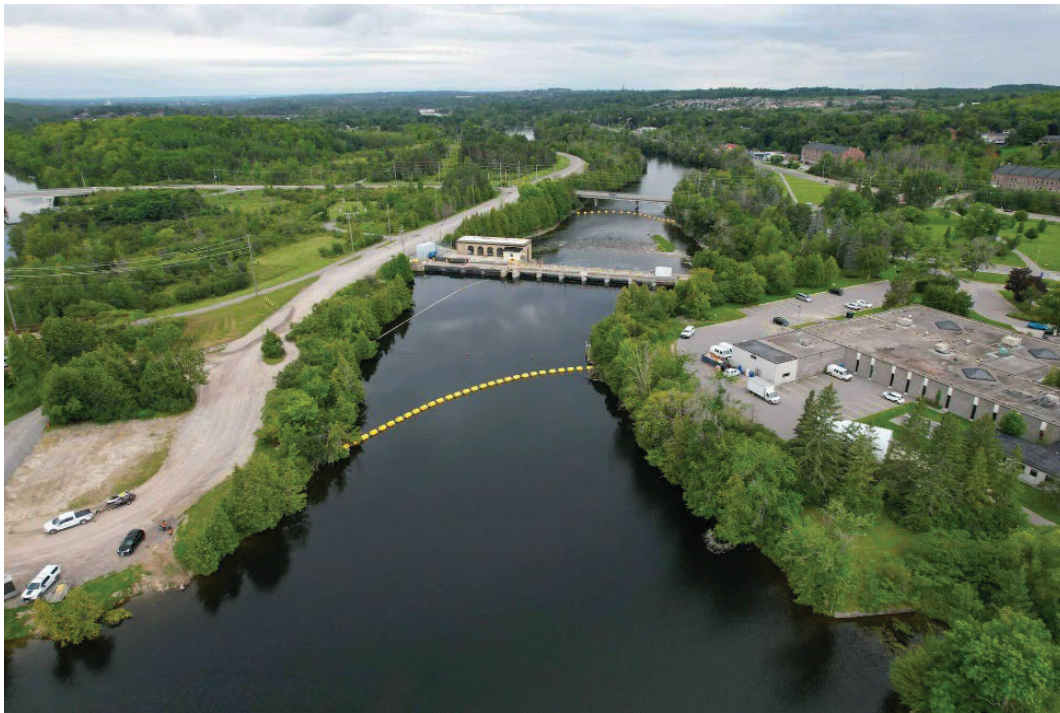
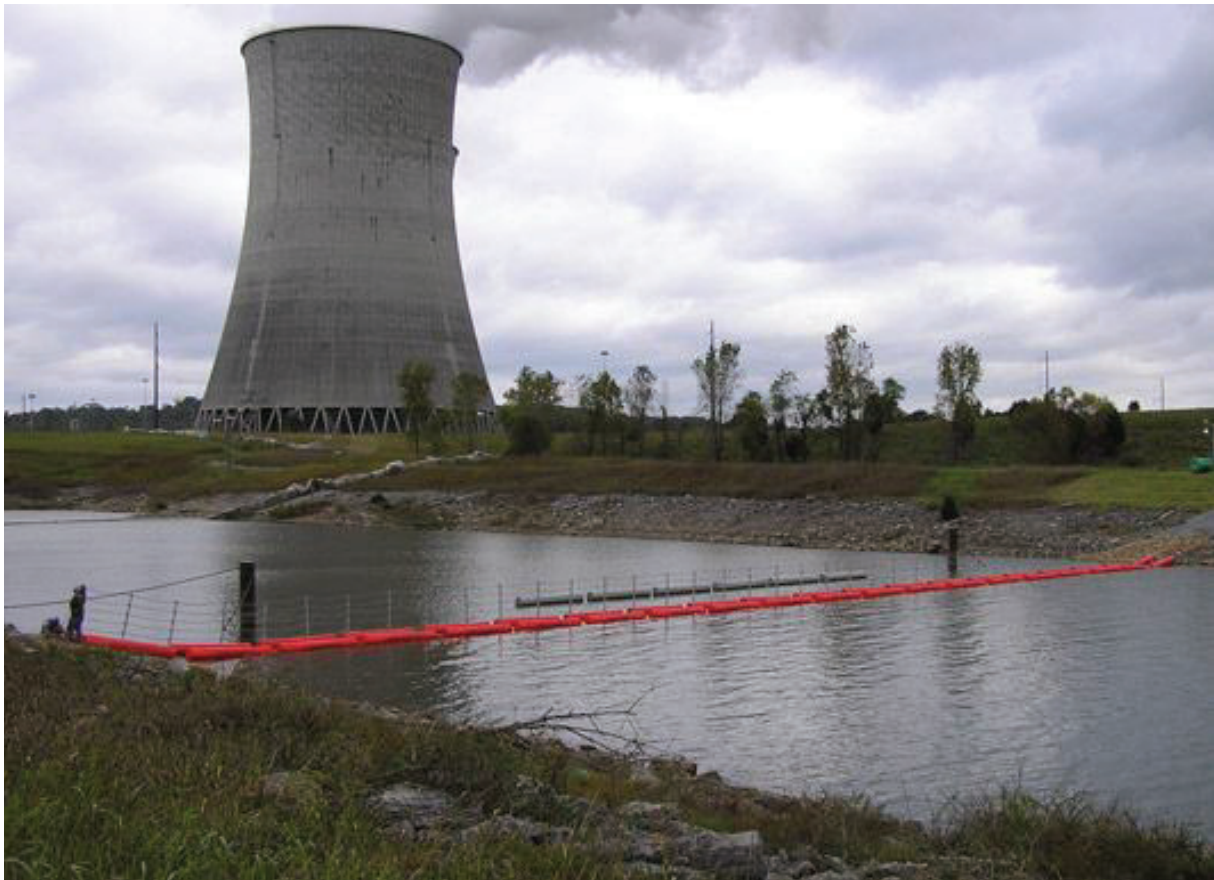
Figures 22. An example of a floating barrier obstructing the entire waterway. *OdinBoom, Floating Barriers*, Worthington Waterway Barriers (accessed June 14, 2024), <https://tinyurl.com/2rptc7ye>.

Figures 23. An example of a floating barrier obstructing the entire waterway. BoatBuster, *Floating Barriers*, Worthington Waterway Barriers (accessed June 14, 2024), <https://tinyurl.com/5n7jrjyd>.

Figures 24. An example of a floating boom barrier obstructing the entire waterway. TuffCat, *Marine Security Barriers*, OFM Engineering (accessed June 14, 2024), <https://tinyurl.com/4smzwhxd>.

The buoys in this case are distinguishable from booms, as defined above, because they do not obstruct passage along the entire Rio Grande River.

The buoys do not obstruct passage along the Rio Grande River, therefore, based on the definition provided, the buoys are not booms.
